Laser Damage Testing of Molybdenum Shutter

May 1999

TARDEC Technical Report No. 13766

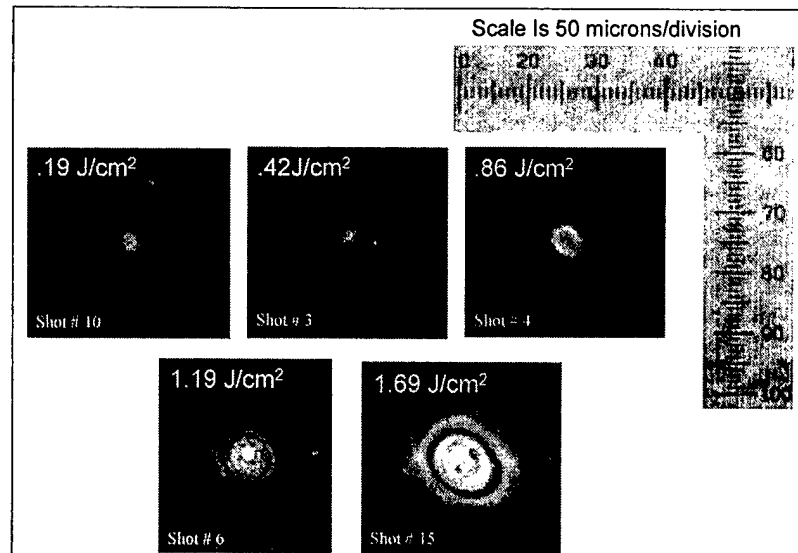
Figure 5. Damage with Increasing Fluence

4.3 While testing the Molybdenum sample we noted that the damaged area increased as the fluence increased. This is illustrated in Figure 5. We also determined that the damage spot size increase is directly related to the increase in input fluence. For example: for site 15 the fluence was 1.69 J/cm² and the area of the damage spot was 159

4.4 After examining the damage sites, it was apparent that several of the damage sites had a ring or halo surrounding the primary elliptical damage site. This effect was seen for input fluences greater than or equal to 1.19 J/cm². It was postulated that this ring was caused by a laser-induced shockwave. The ring may be the result of a shock propagating out from the center of the damage site, ejecting coating material at the peak of the first crest. The dark ring may be coating left intact at the first minimum.

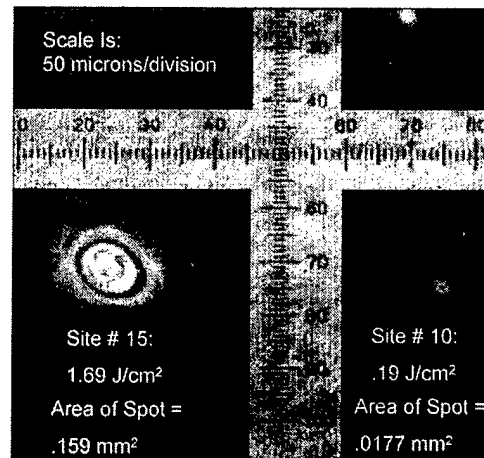
Figure 6. Comparison of Damage Spot Areas

mm² and for site 10 the fluence was 0.19 J/cm² and the area of the damage spot was 0.0177 mm² (see Figure 6). The ratio of the two site's fluences (8.90) and damage spot areas (8.98) was nearly identical.
